MILL CREEK NO. 2 DAM  
NDI I.D. NO: 735

PHASE I INSPECTION REPORT  
NATIONAL DAM INSPECTION PROGRAM

Mill Creek Number 2 Dam (NDI-735),  
Ohio River Basin, Mill Creek,  
Cambria County, Pennsylvania.  
Phase I Inspection Report.

<sup>11</sup> SEPTEMBER 1978

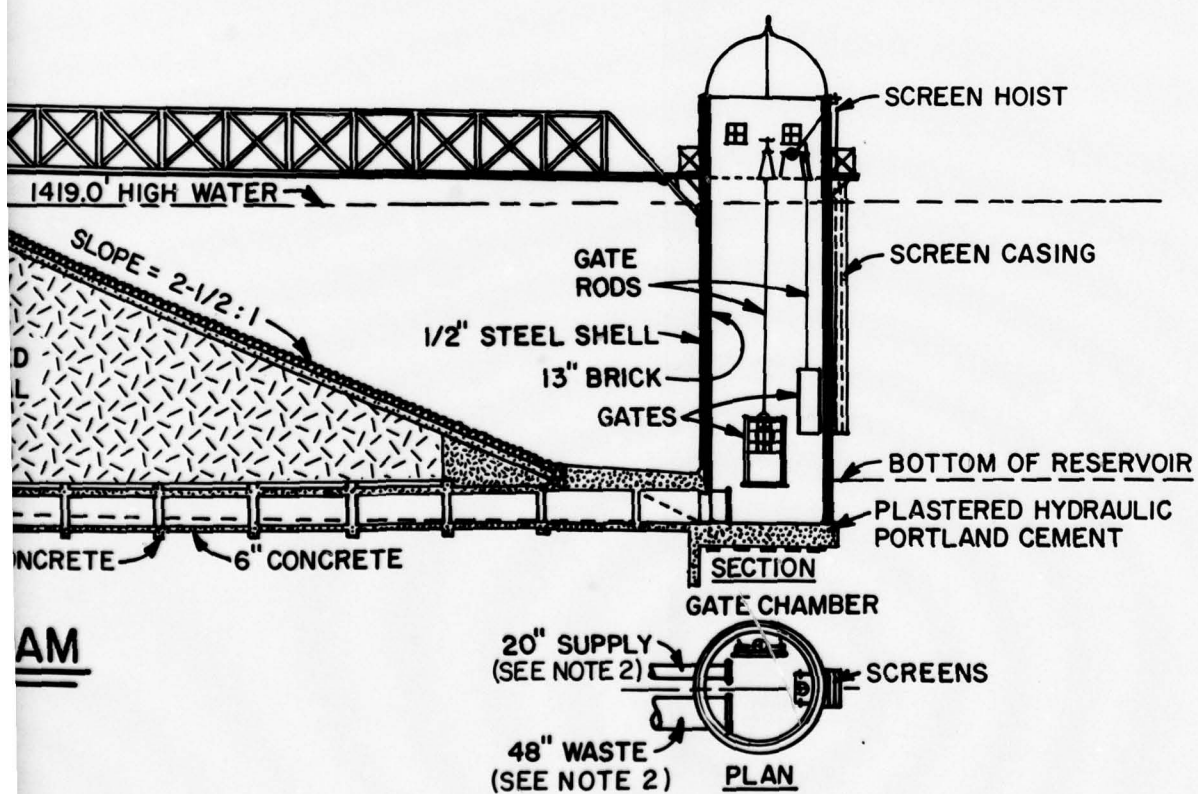
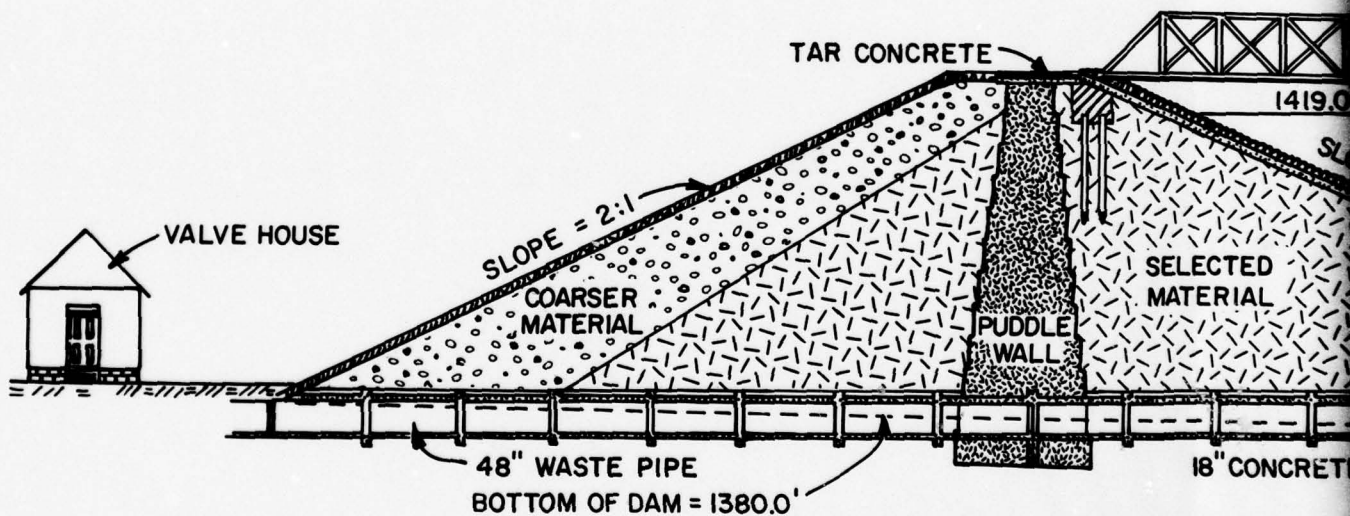
PLATE 2

a. As designed, the dam is a zoned embankment consisting of select material with puddle-clay core and a coarse material section forming the downstream section (Plate 2). The 1914 state report indicates that the design also incorporated a six-foot-wide puddle-clay core located at the upstream toe of the dam, which was extended into the "natural clay." The state report also indicates that the puddle-clay core, which was 17 feet wide at the base level of the dam, was extended two feet into the bedrock at the valley floor and 25 feet into the abutments. Plate 3 presents a plan and longitudinal section of the dam.

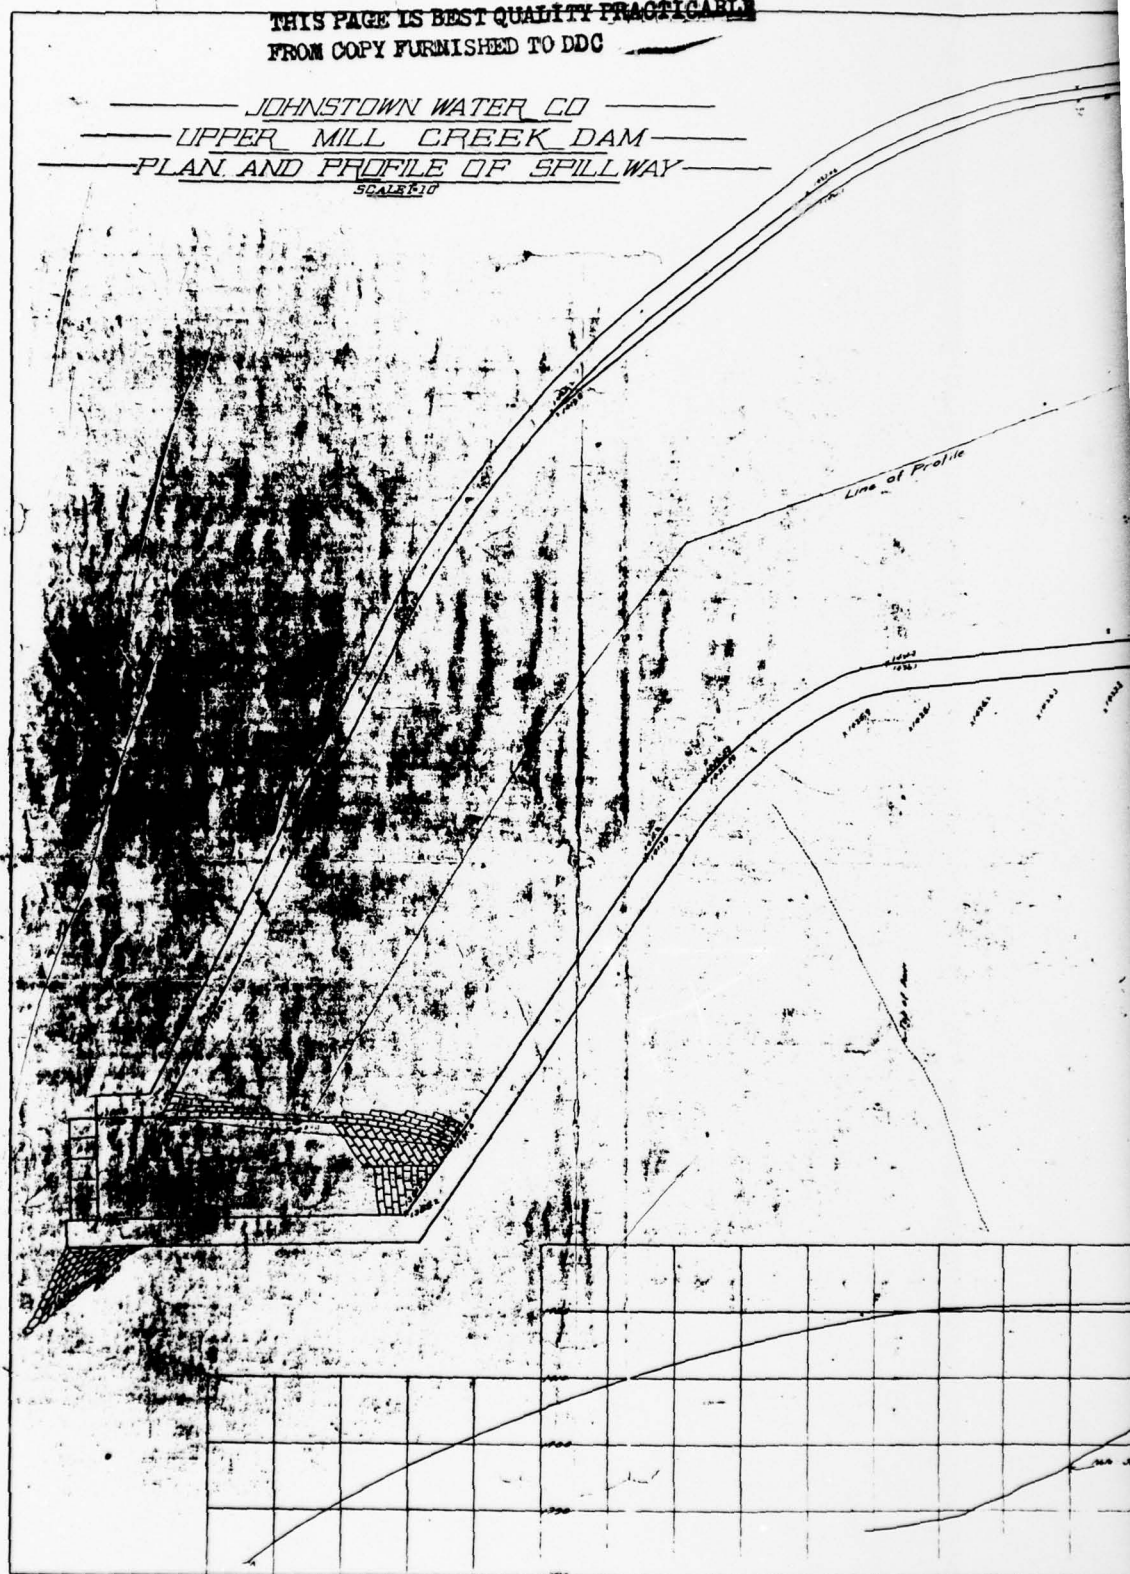
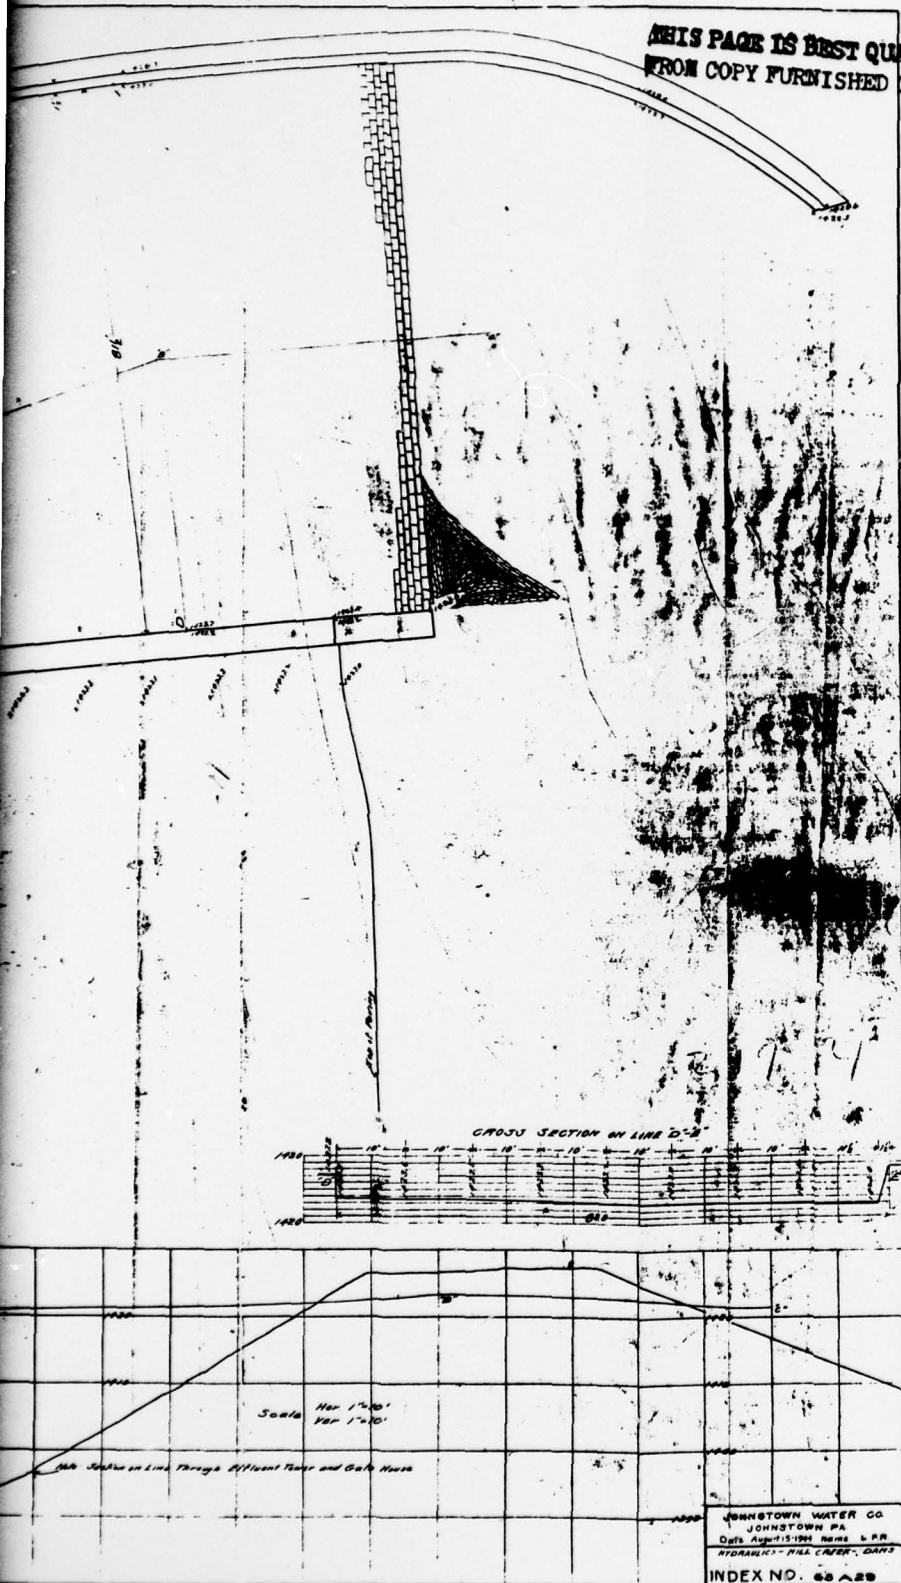
PLATE 4

c. Appurtenant Structures. The appurtenant structures for the dam consist of a combined emergency and primary spillway and the outlet works. The primary spillway is located in a cut on the right abutment (Plate 4). The spillway is a rectangular channel 82.5 feet wide at the control section with a stone-paved bottom and masonry walls. The profile of the spillway shows a broad-crested hydraulic control section. The crest of the spillway is three feet nine inches below the dam crest, as measured in this inspection. As designed, the approach channel rises 1:35 (vertical to horizontal) to the control section and falls 1:20 from control section to the start of the spillway chute.
